# Road Maintenance & Deer Stands

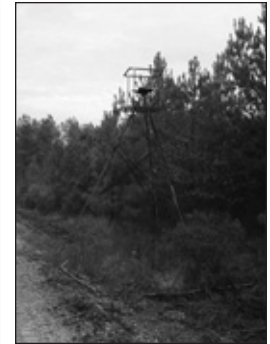
*As you can see from these two examples, road maintenance was hindered by the legs of these stands. Consequently, the ditches weren't able to be pulled properly and water can now pond up underneath the stand and run over the road.*

We are simply reminding clubs to please make sure **all deer stands placed along company roads are on the back slope of the ditch** so our road contractors aren't hindered. Any existing stands sitting on the top of ditches also need to be moved as quickly as possible. Deltic Timber Corporation cannot be responsible for damage caused to stands during our road maintenance operations. As mentioned before, having well-maintained roads is a benefit to our company, the numerous individual hunting clubs, and the water quality of our environment.
